OPERATION PLUMBBOB

Project 30.4

RESPONSE OF PROTECTIVE VAULTS
TO BLAST LOADING

Ammann & Whitney
New York
April 1961

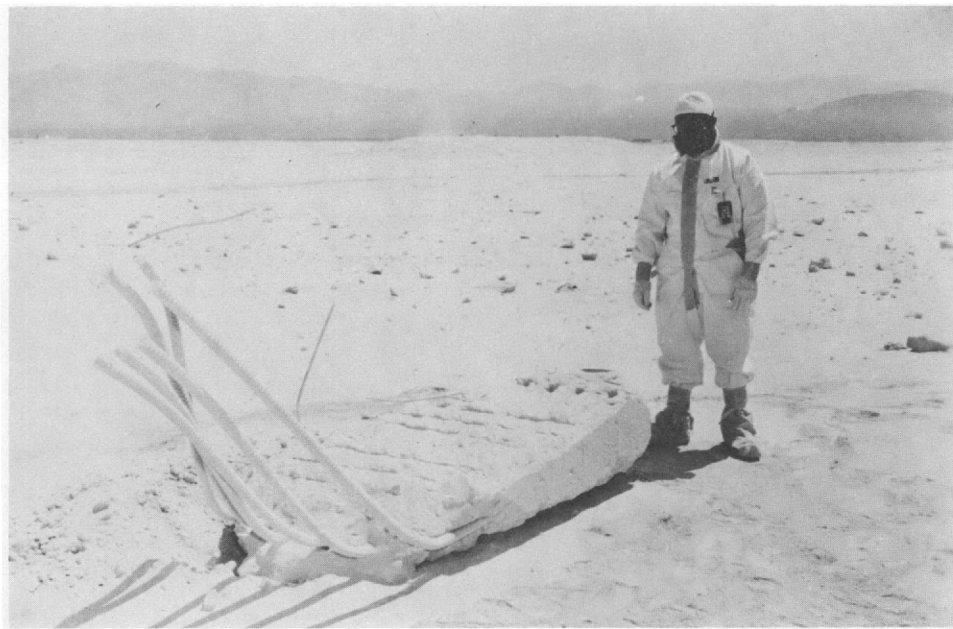
One piece of the concrete wall approximately 6 ft by 3 ft 3 in. by 1 ft 6 in. was found 80 ft to the right rear (WNW) of the structure (Fig. 3.3), and a similar piece was found 85 ft to the left rear (WSW) of the structure.

Fig. 3.3—Postshot, piece of concrete debris found 80 ft from vault.

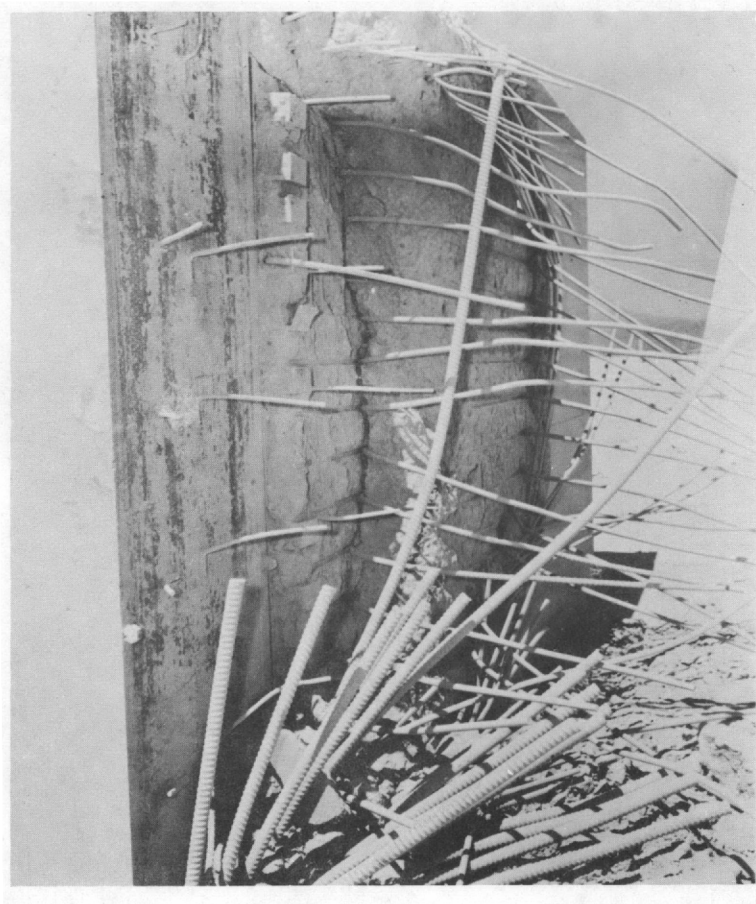
The exposed fractured section of the remaining concrete wall showed full-height vertical cracks along the planes of the reinforcement separating the walls into three slices (Fig. 3.4). There were few, if any, breaks through the aggregate. The majority of the $\frac{3}{8}$ -in.-diameter form ties welded to the sides of the door box frame were bent but were not torn off. The outer layers of wall reinforcing bars were torn out for approximately two-thirds of the vault length. Although the damage to the side walls was extensive, the vault interior was well protected.

Fig. 3.4—Postshot, north face close-up showing separation of concrete along planes of reinforcement.

The separation of the reinforcing steel bars from the concrete, the separation of the concrete along the planes of the reinforcing bars, and the reduction of the concrete to debris with few breaks through the aggregate also indicated the poor adhesive qualities of the concrete in place. The damage might have been avoided completely had the front face joints been completely sealed to prevent the entrance of the high positive pressures.

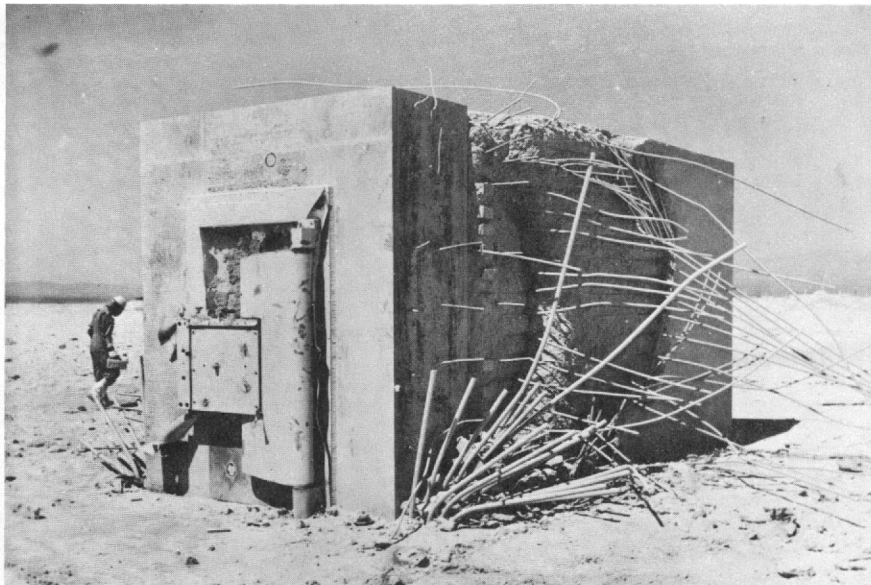
The vault door withstood the blast without structural damage. The front face of the vault was partially blackened by the thermal radiation (Fig. 3.5). The light-gauge stainless-steel finish plates were warped and in some cases torn off (Fig. 3.6). The operating hardware on the surface of the pressure-system box was blown off, apparently in a downward direction. The hardware included two combination-lock dials, a pressure-system handwheel, and a throw-bolt handle. The hardware, except for the cast-iron pressure-system handwheel, which was fractured into several pieces, was found within a 10-ft radius from the door. The housing of the emergency combination dial, which was attached by means of three $\frac{1}{2}$ -in.-diameter bolts, was blown off as a unit. The pressure housing, attached to the door by twelve 1-in.-diameter bolts, had a slight downward shift. The top $\frac{1}{2}$ -in. plate of the pressure-system housing was deflected, but a similar plate below the housing was not damaged.

Fig. 3.5—Postshot, front and north faces of vault.

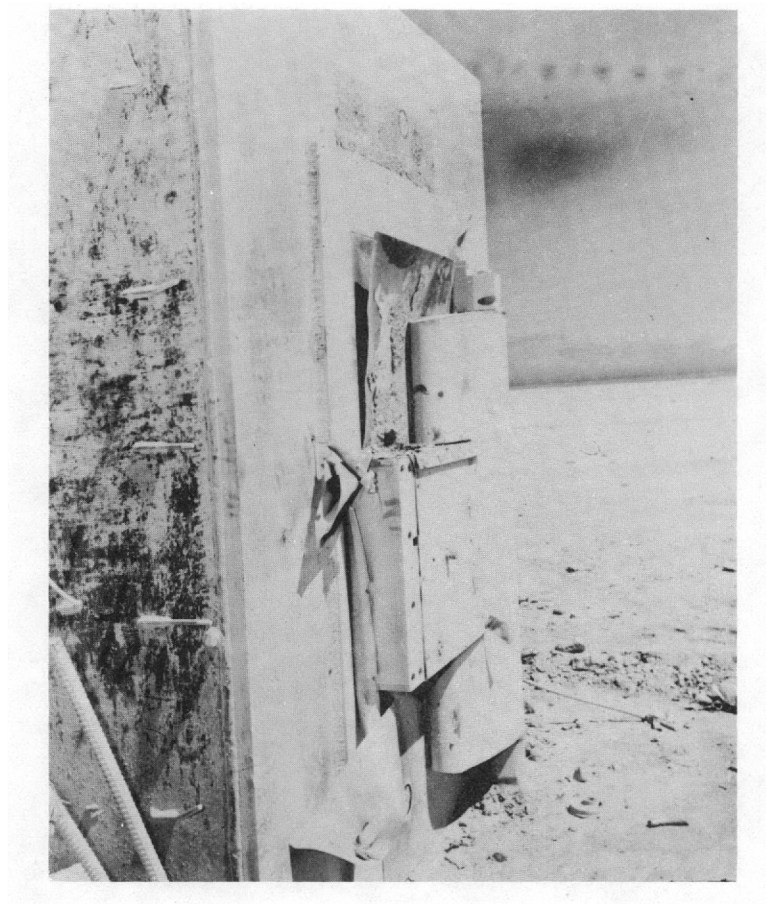
Fig. 3.6—Postshot, close-up view of front face from south showing damage to light-gauge finish plates and hardware.

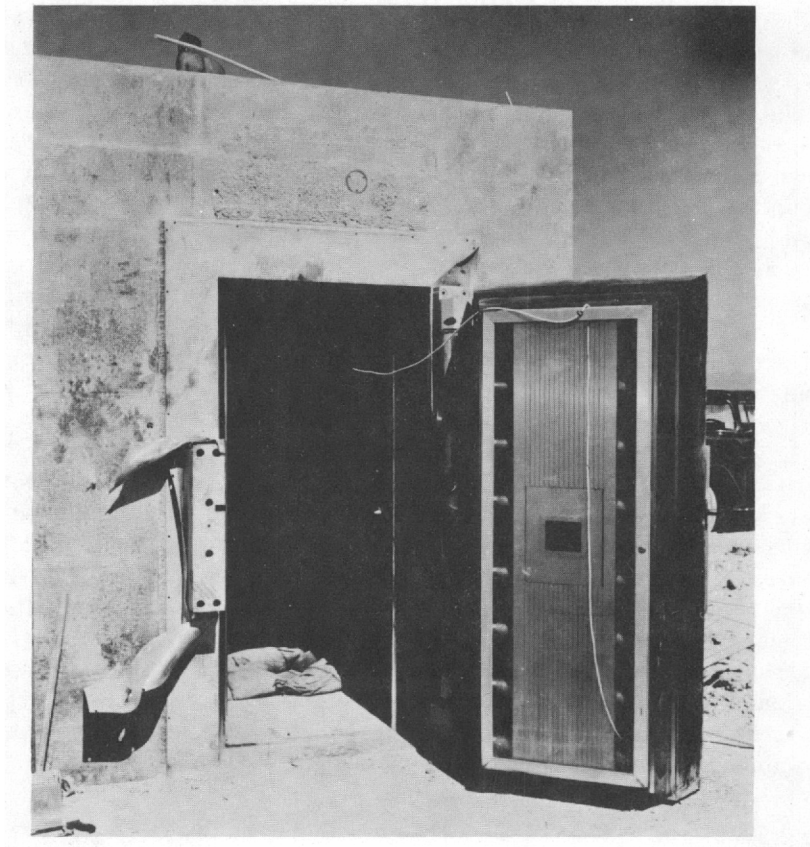
Fig. 3.7—Postshot, front face of vault, door open.

A visual inspection of the door hinge and door frame showed no apparent damage except for minor surface pitting. The original fit was apparently maintained, the door remaining parallel to its frame in all planes, thus indicating a tight fit at the seal between the door and striker. Although it was not practical to perform an air test prior to opening the door, it did not appear that the airtight and watertight condition of the door was affected by the blast.

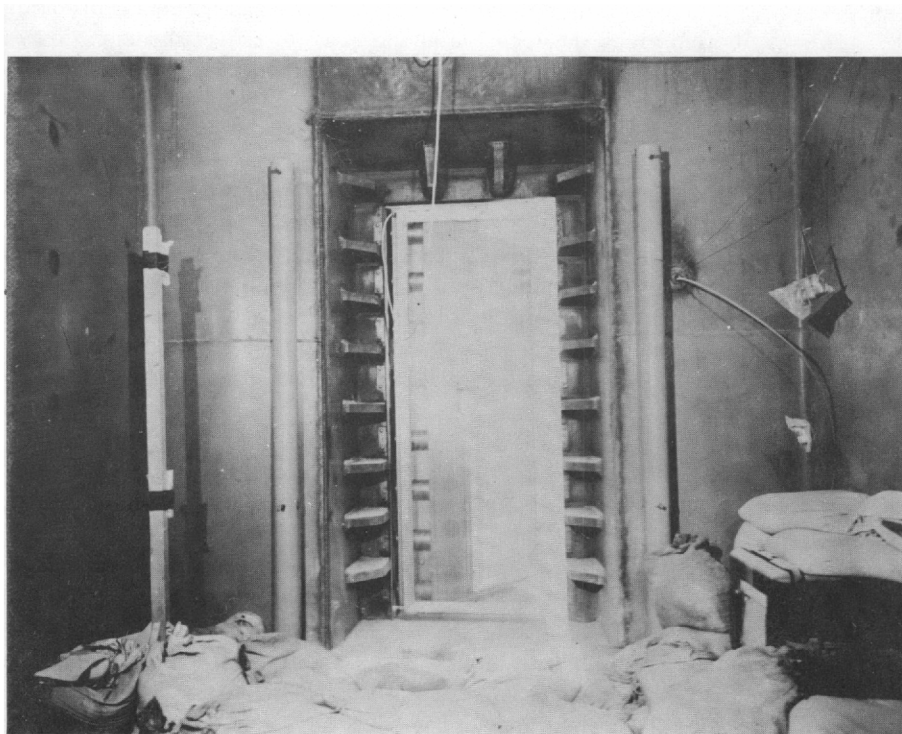
Fig. 3.8—Postshot, interior view looking toward door.

The $\frac{1}{2}$ -in. steel-plate lining of the vault was undamaged except for the wall lining directly behind the vertical sections of the door box frame, where the plate was dished inward (Fig. 3.8). A joint between the door box frame and the frontmost Z-clip batten plate of the vault lining was partially exposed when the side-wall concrete was torn off, allowing the blast pressure to infiltrate and build up in the $\frac{1}{2}$ -in. space between the door box frame and the vault lining.

The wall plate behind the left side of the door box frame (looking into the vault) was dished inward a maximum of $\frac{3}{4}$ in., and the plate behind the right side of the door frame was dished inward a maximum of $3\frac{1}{2}$ in. Both maximum deflections occurred 12 in. from the side walls. Even with the seemingly large deformations, these plates still provided complete protection. There was no apparent fracture of the $\frac{1}{2}$ -in. plate welds.

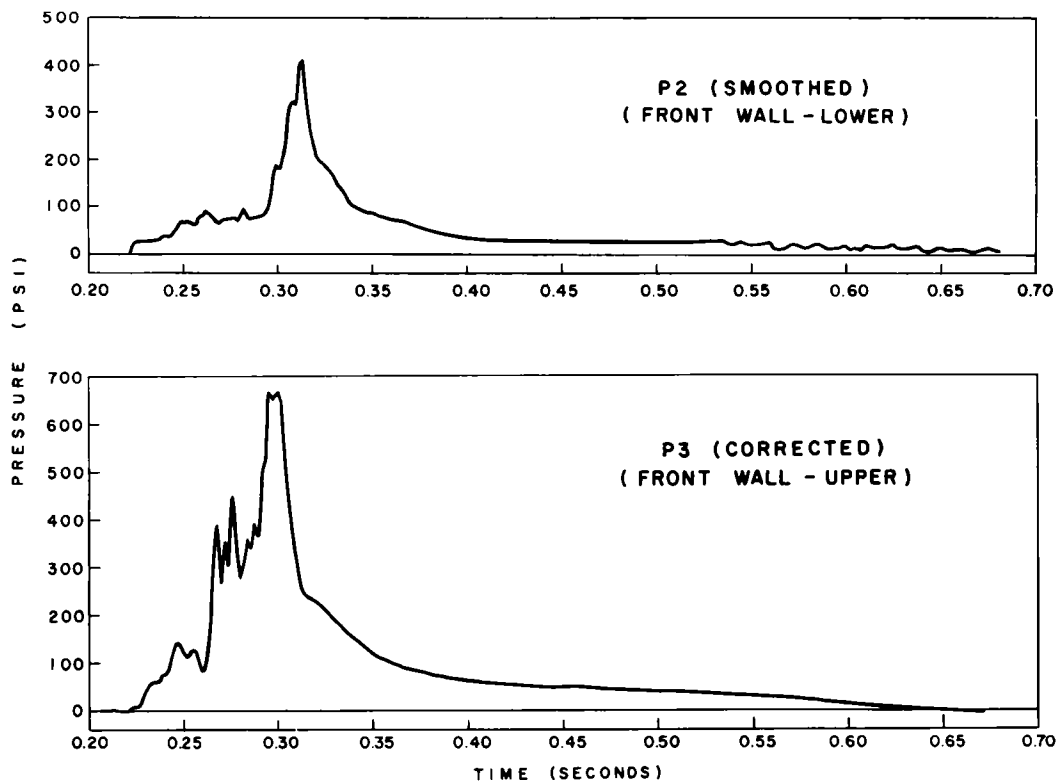
Fig. 3.12— Adjusted front-wall gauge records.

The free-field dynamic-pressure gauge and the two gauges on the front face of the vault were dust filled, and, although an estimate has been made of their impulses, no suitable modification has been found to correct the records. A smoothed plot of the record from gauge P2 and a corrected plot for the record from gauge P3 are presented in Fig. 3.12 as the adjusted front-wall gauge records.

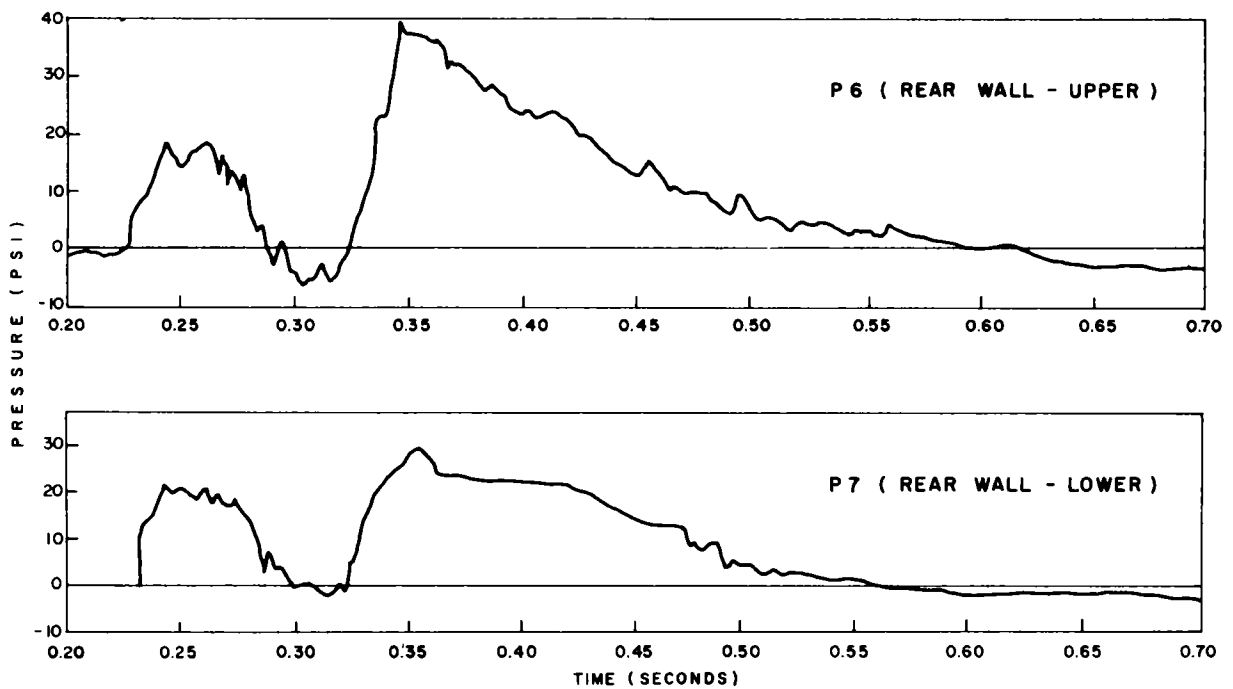
Fig. 3.13— Modified rear-wall gauge records.

Gauge P6 (rear wall, top) picked up an induced 60-cycle signal from electrical equipment installed as another phase of Project 30.4. The effect of the 60-cycle signal (based on the average amplitude of the signal before and after the shock signal) was arithmetically filtered out, and the pressure-time curve shown in Fig. 3.13 resulted.

As shown in Figs. 3.10 and 3.11, the amplitude of gauge P7 was less than one-fourth that of gauge P6. Both gauges were located on the back wall of the structure. Impulses from gauges on the back of a 6- by 6- by 20-ft structure¹ showed considerable scatter but gave no conclusive evidence of an impulse gradient with height above the ground, even though there was an appreciable gradient on the front. It has been assumed that the same holds true for the test vault. Although no mechanical or electrical error could be found, one was suspected, and the amplitude of P7 has been arbitrarily increased by a multiplication factor of 4.7 to make its positive-phase impulse equal to P6. The results, when compared with the record from P6

without the 60-cycle signal, indicate that, except for amplitude, P7 is a credible record (Fig. 3.13).

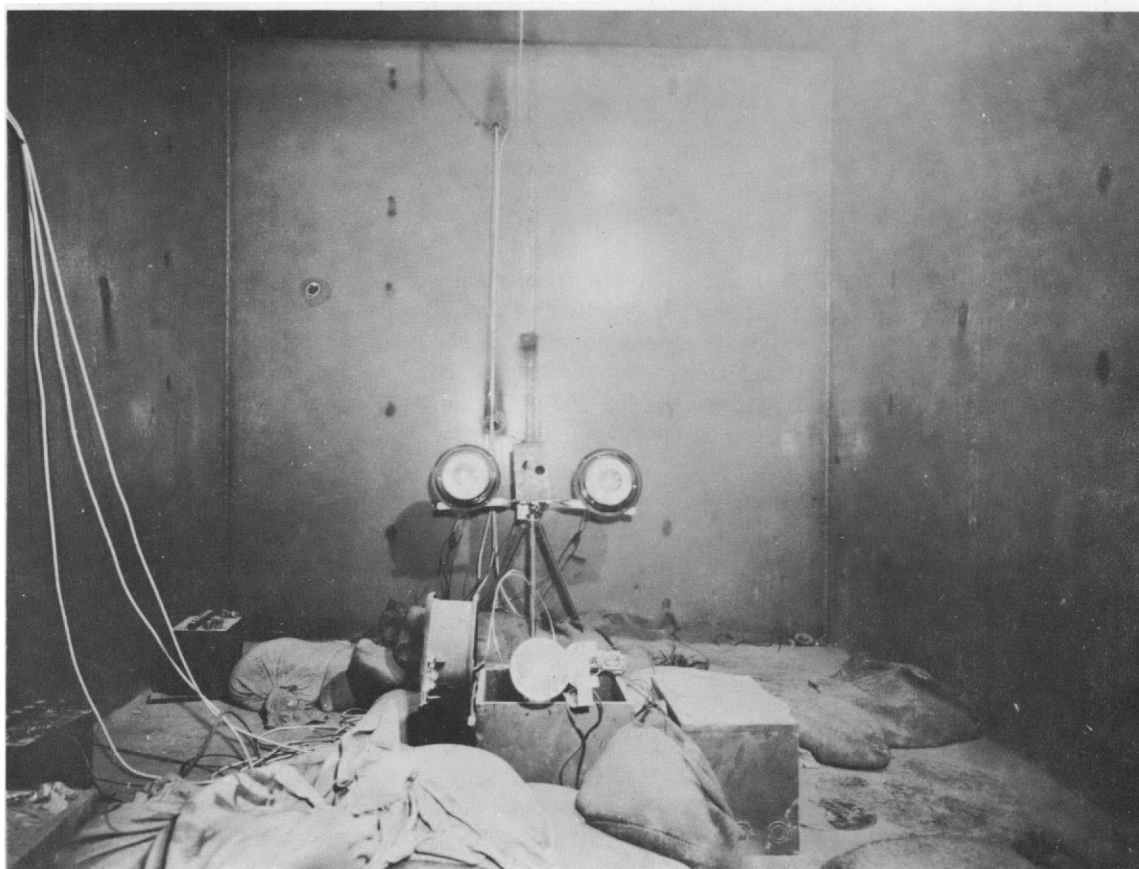
The vault contents were only slightly disturbed by the blast. The sandbags against the front wall were shifted a few inches toward the rear of the vault. The movie camera, mounted

Fig. 3.19—Postshot, view looking toward rear showing camera tilt.

on a tripod attached to the floor lining by three machine screws, was tilted upward approximately 10 deg (Fig. 3.19) from its original position. The camera operated as planned, running 40 ft of film. The developed film, however, was completely fogged. The two clinical type thermometers registered 88°F, and the 24-hr American stylus temperature recorder showed no variation in temperature from H-6 hr through H+18 hr, remaining constant at 88°F. The Leeds & Northrup thermocouple recorder ran 20 min; however, the bulb connection at the exterior front face of the vault was blown off, and the temperature recorded on the chart dropped from 100 to 0°F and remained at 0°F for the duration of its run. The lag in the mechanical equipment was too large to record the temperature in the time interval between the arrival of the thermal wave and the arrival of the shock wave. Figure B.16 shows the vault interior before preshot sandbagging of the instrumentation.
